Docket No. SA-537

NATIONAL TRANSPORTATION SAFETY BOARD

Attachment 1 – Photographs

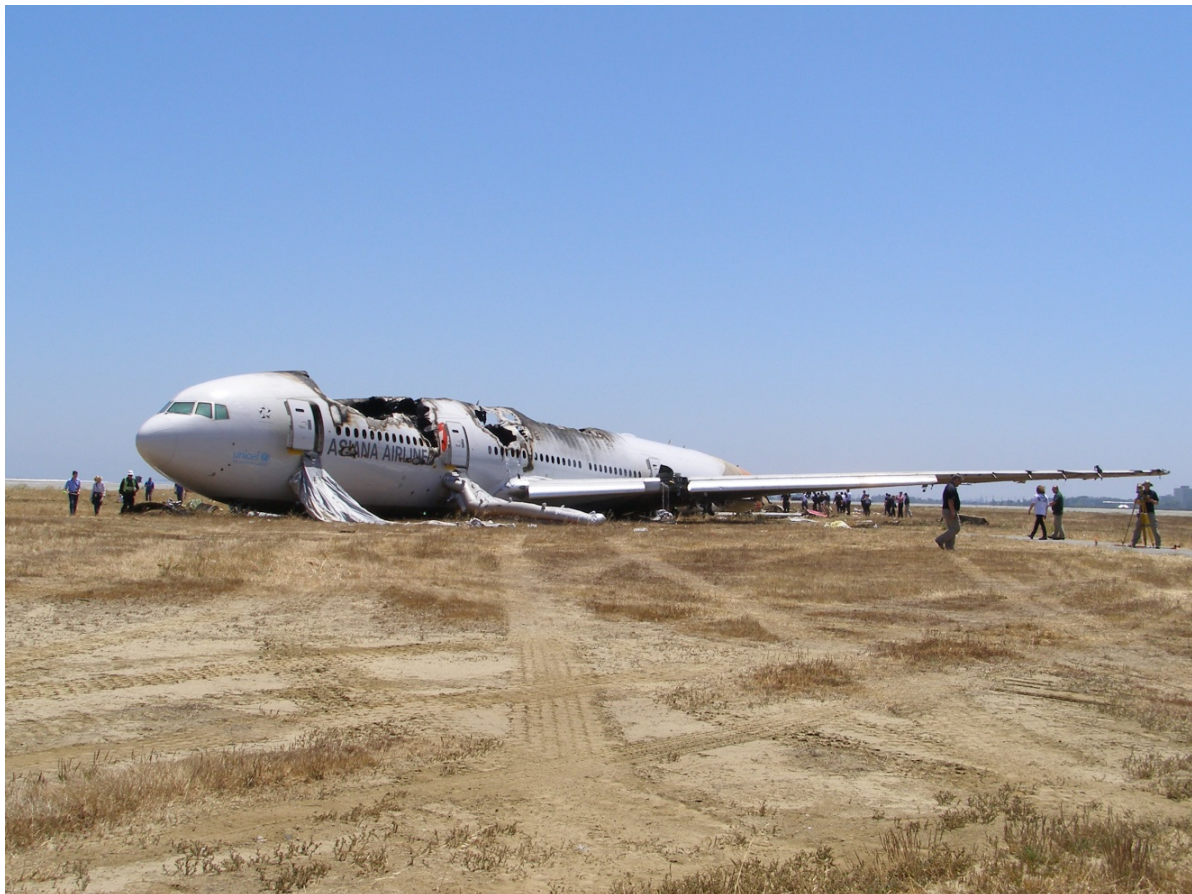
Photo 2. Left side of airplane from the 11 o'clock position.

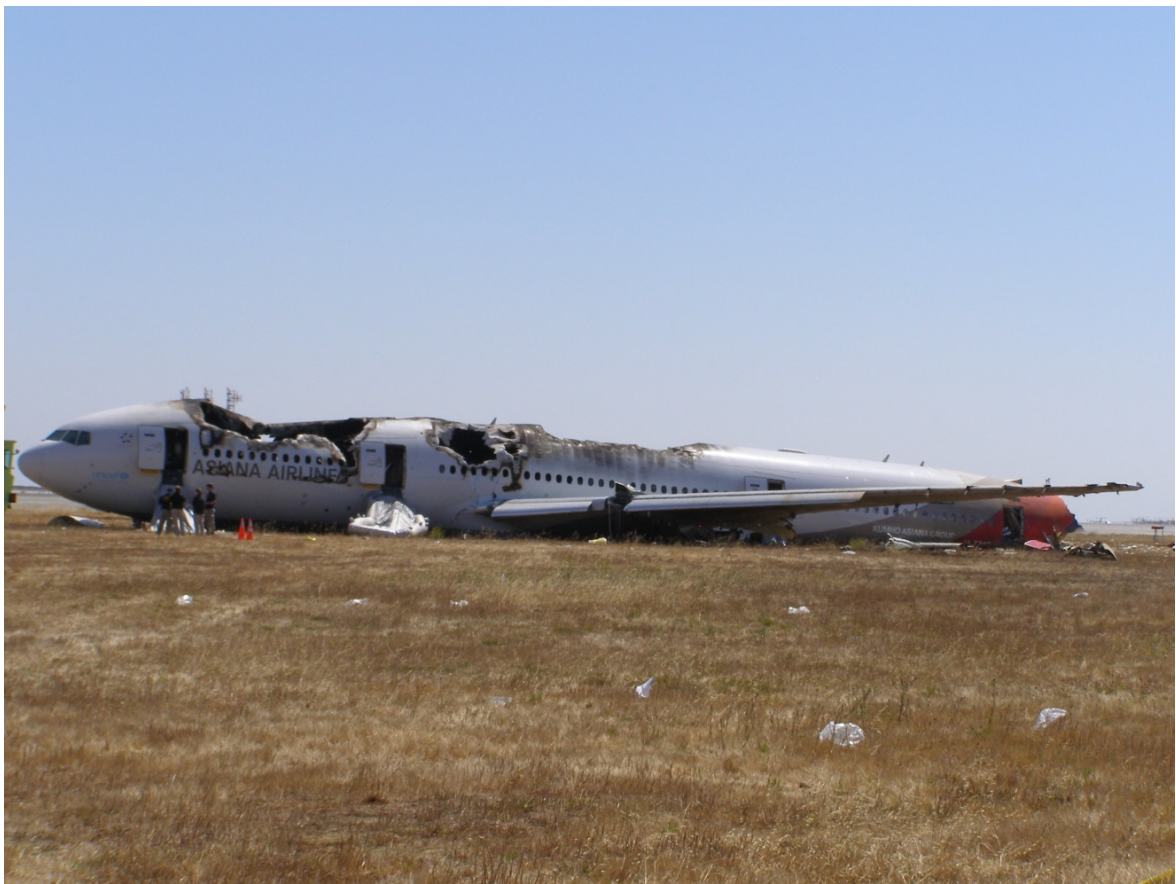
Photo 3. Left side of airplane from the 9 o'clock position.

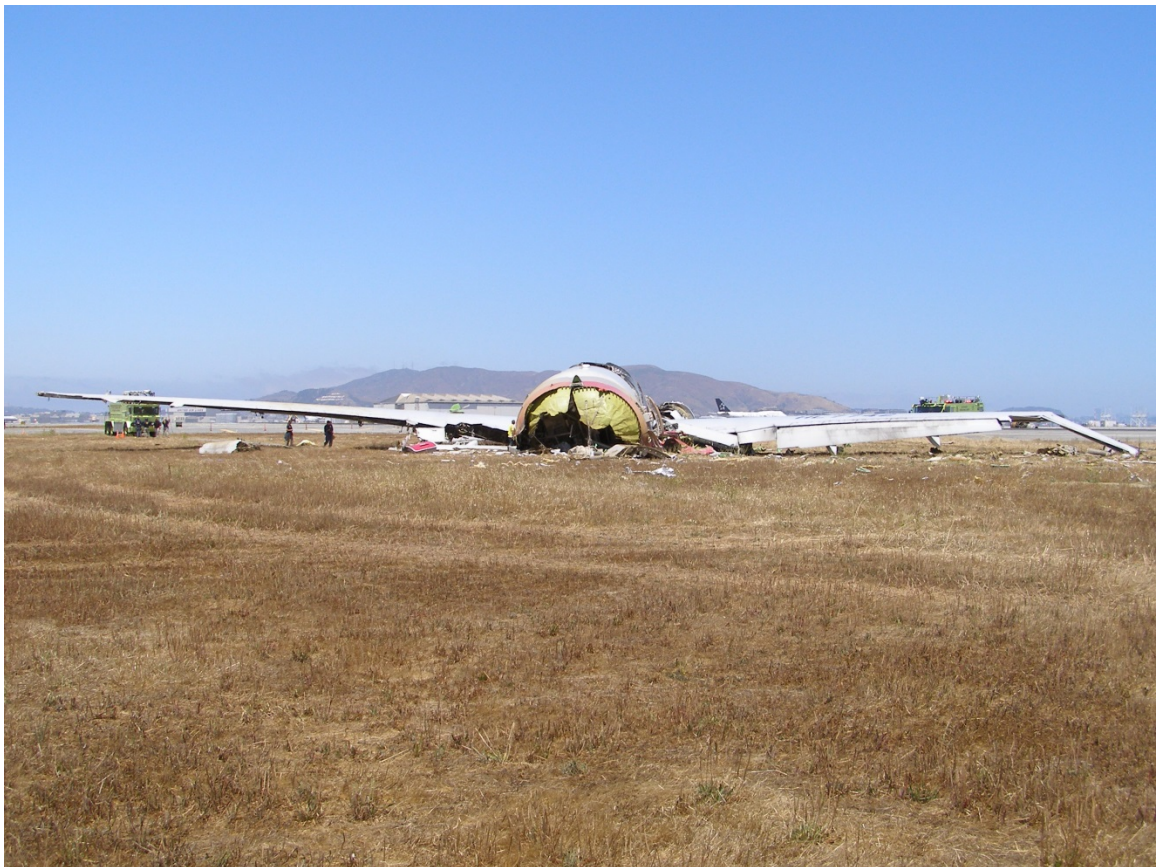
Photo 4. Aft of airplane from the 6 o'clock position.

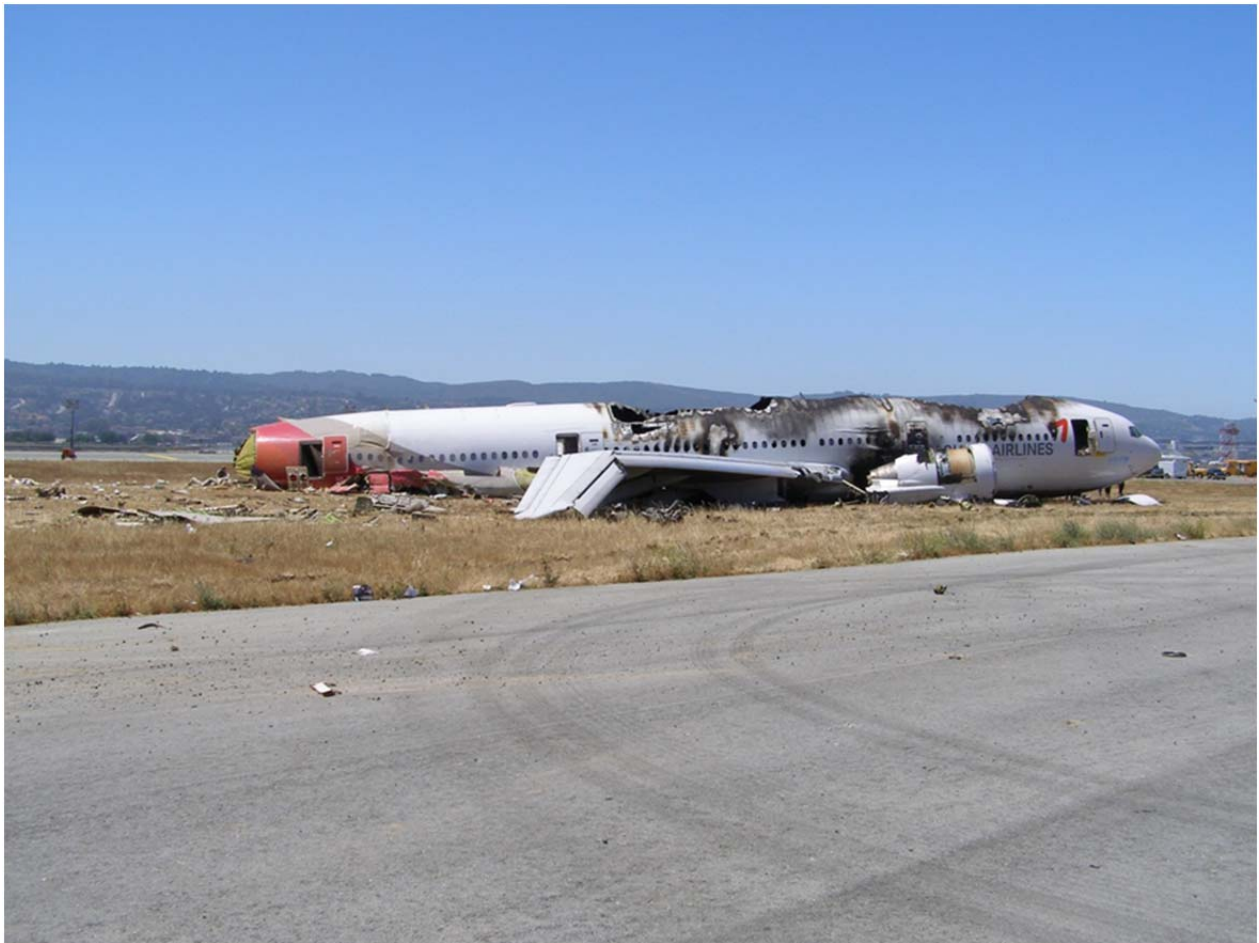
Photo 5. Right side of airplane from the 3 o'clock position.

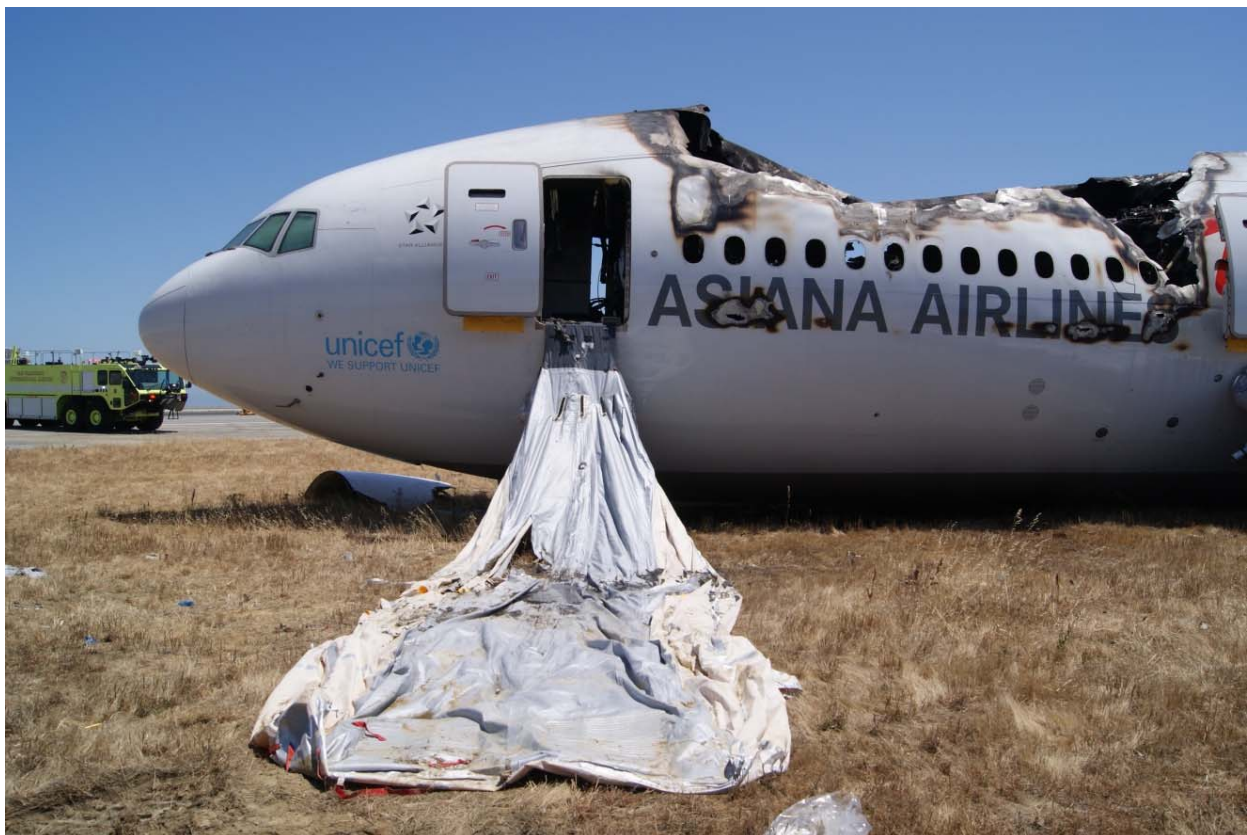
Photo 6. Door 1L slide/raft.

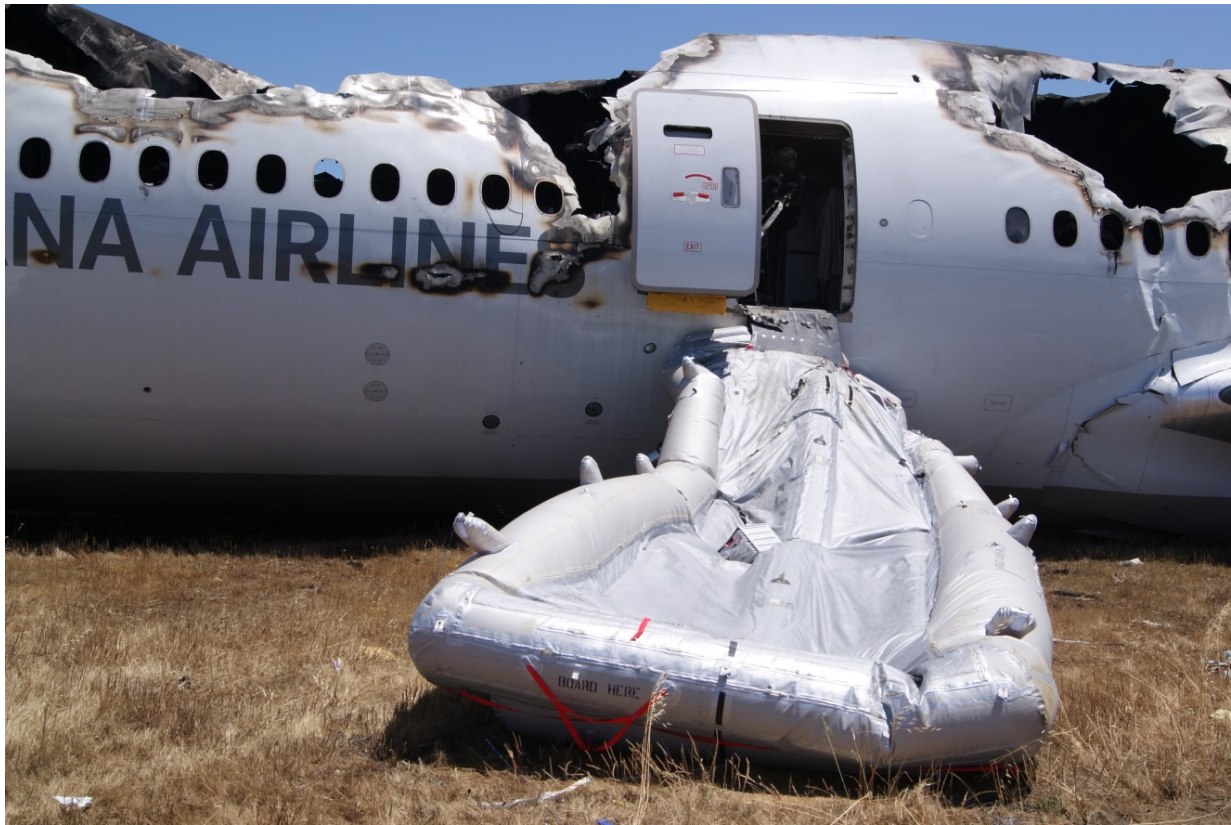
Photo 7. Door 2L slide/raft.

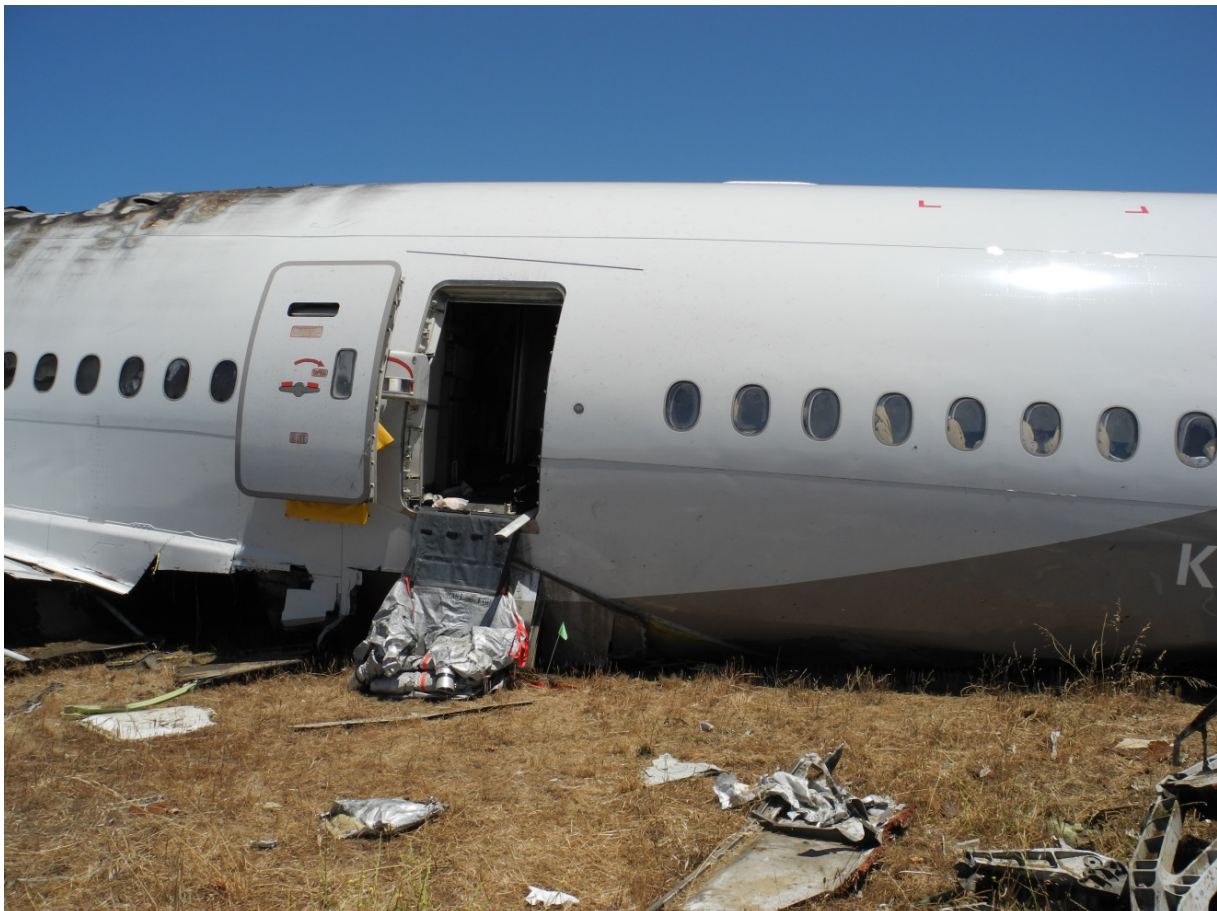
Photo 8. Door 3L slide/raft.

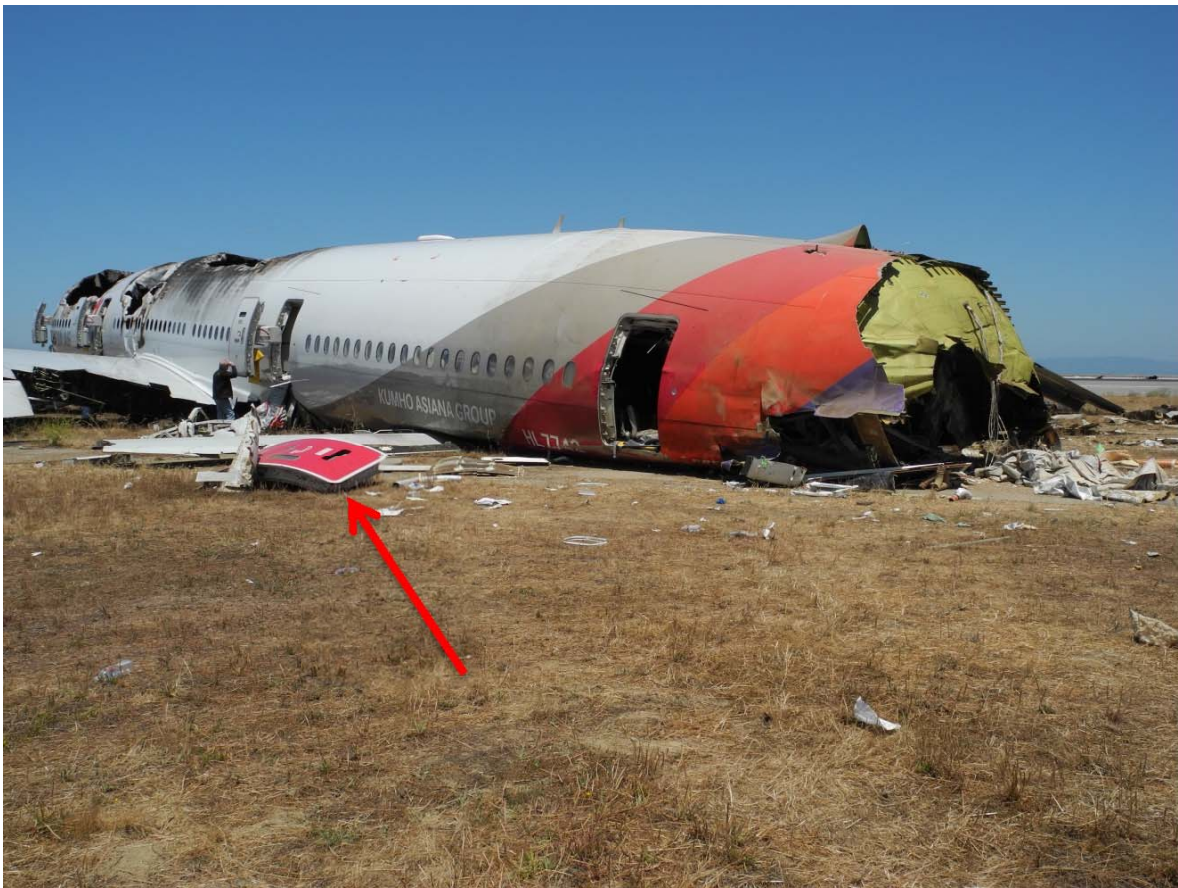
Photo 9. Door 4L.

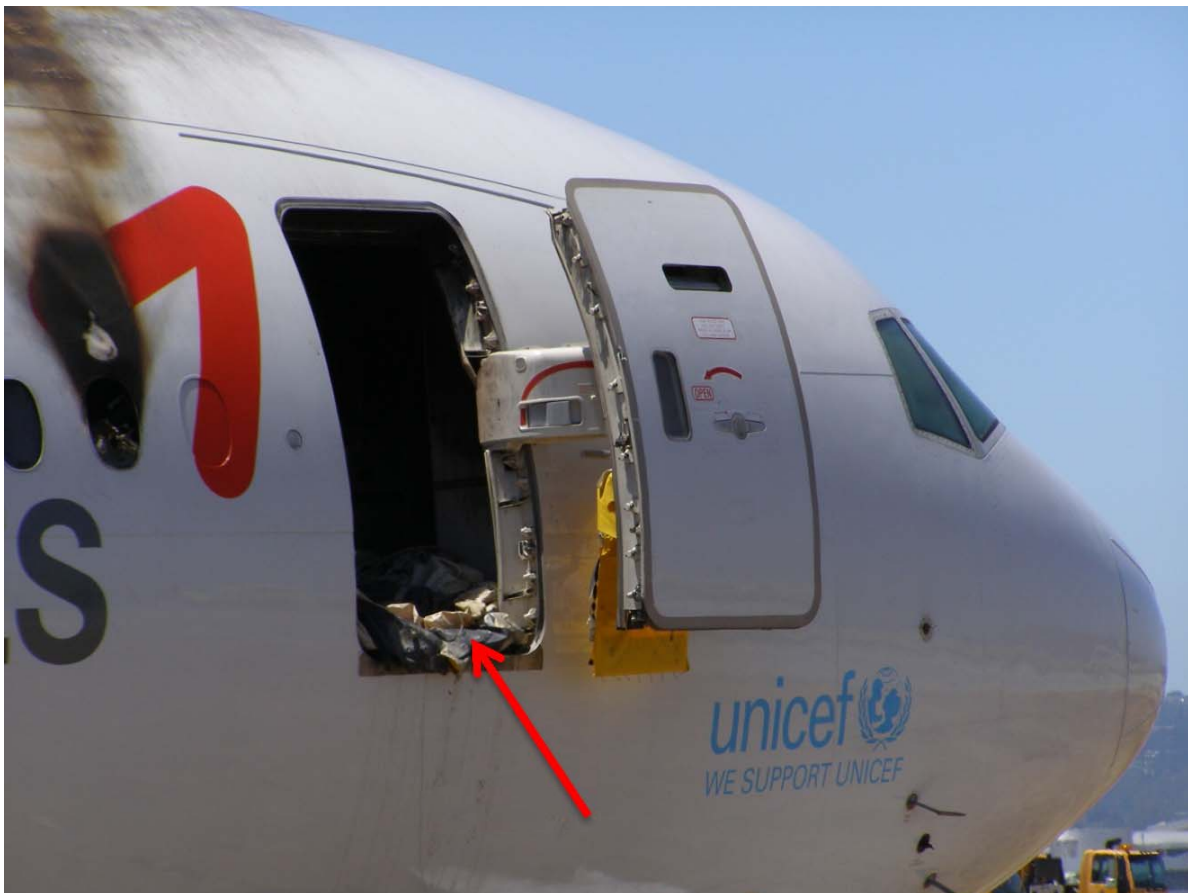
Photo 10. Door 1R slide/raft.

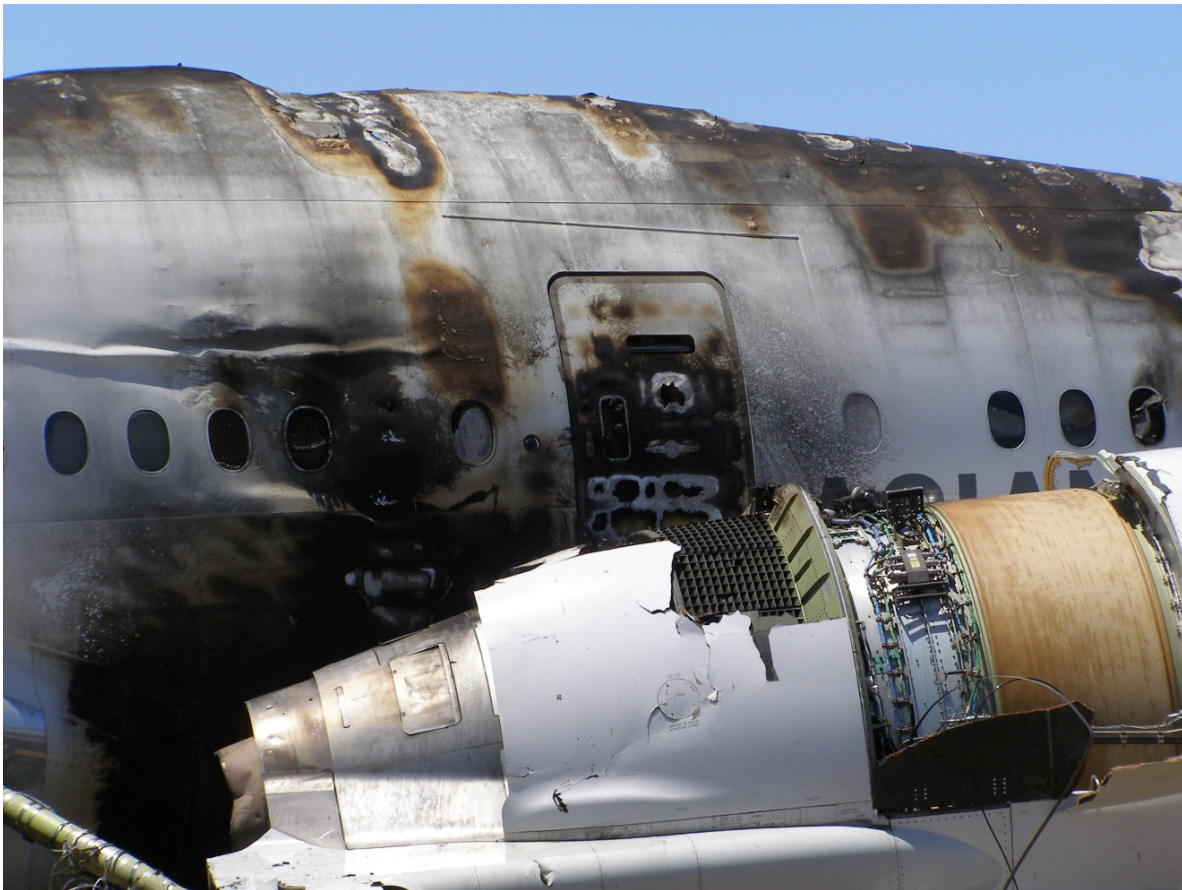
Photo 11. Door 2R.

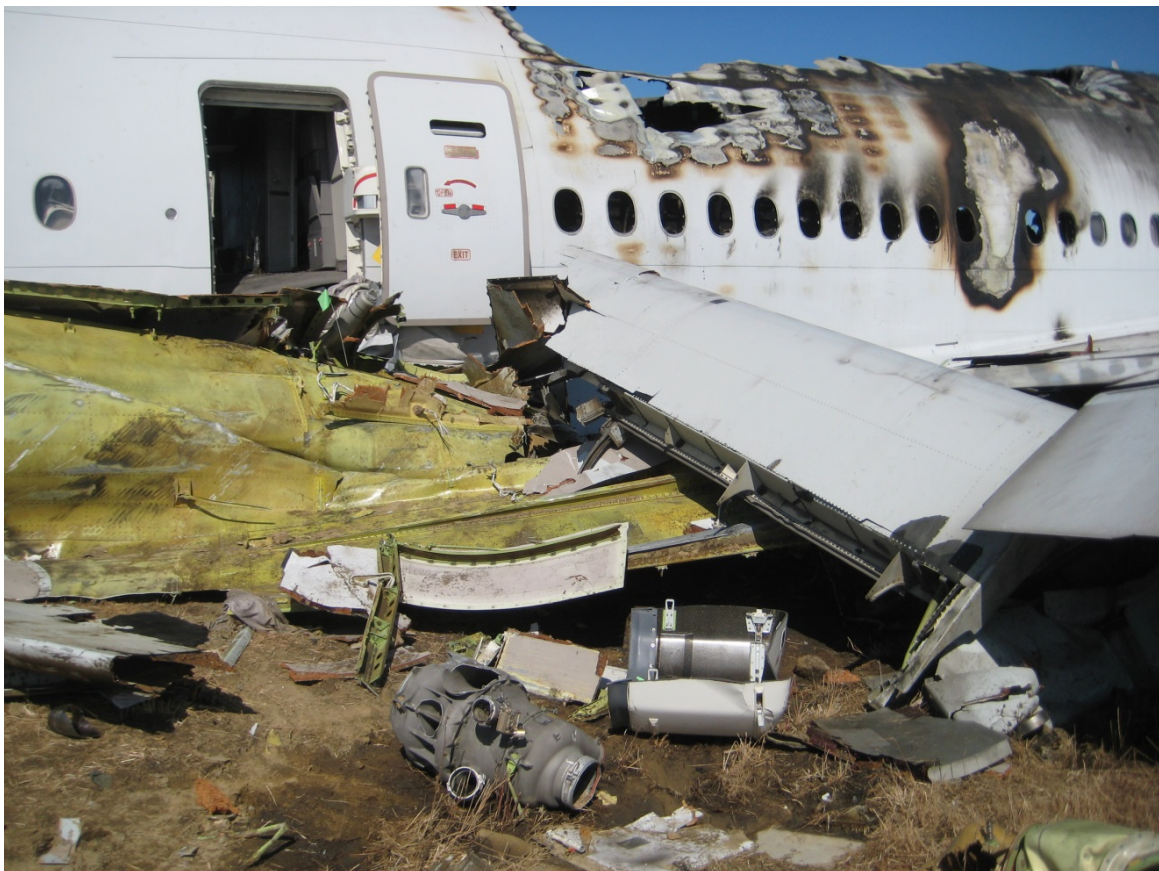
Photo 12. Door 3R.

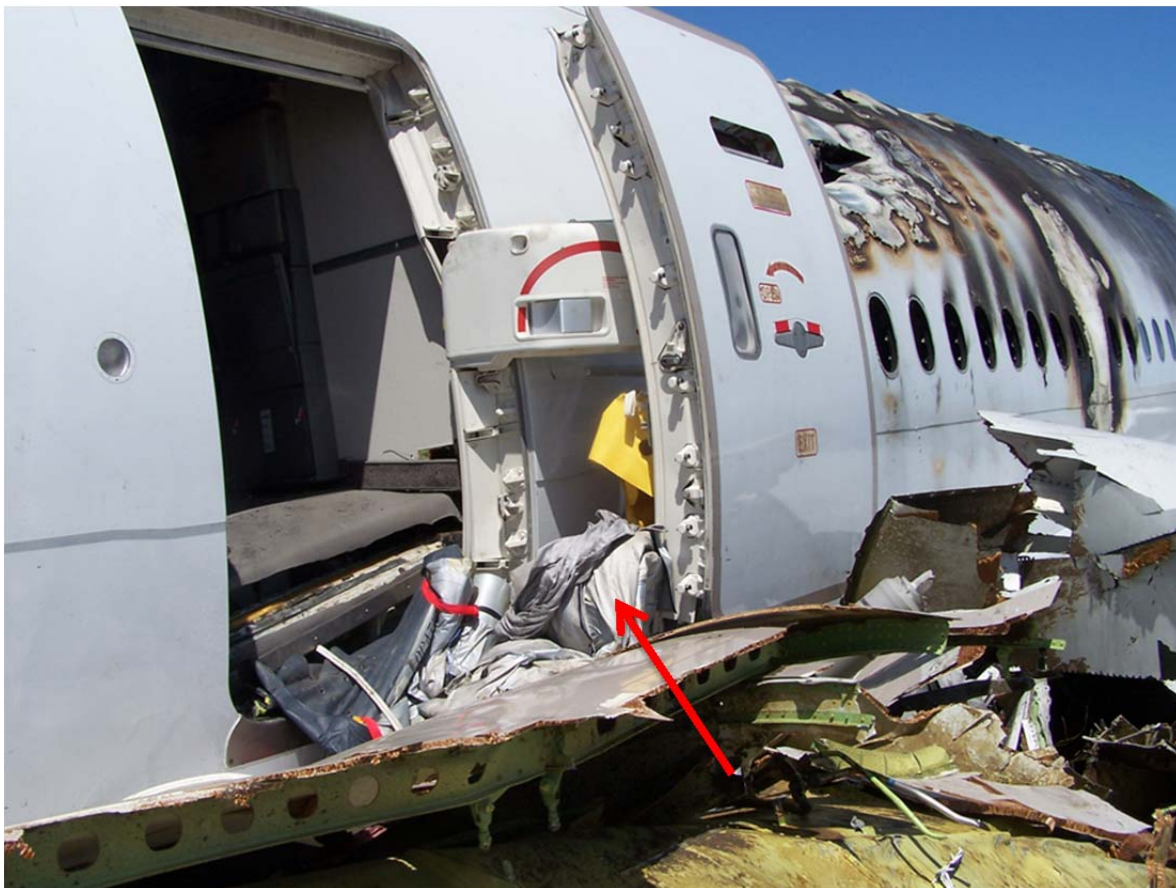
Photo 13. Door 3R slide/raft.

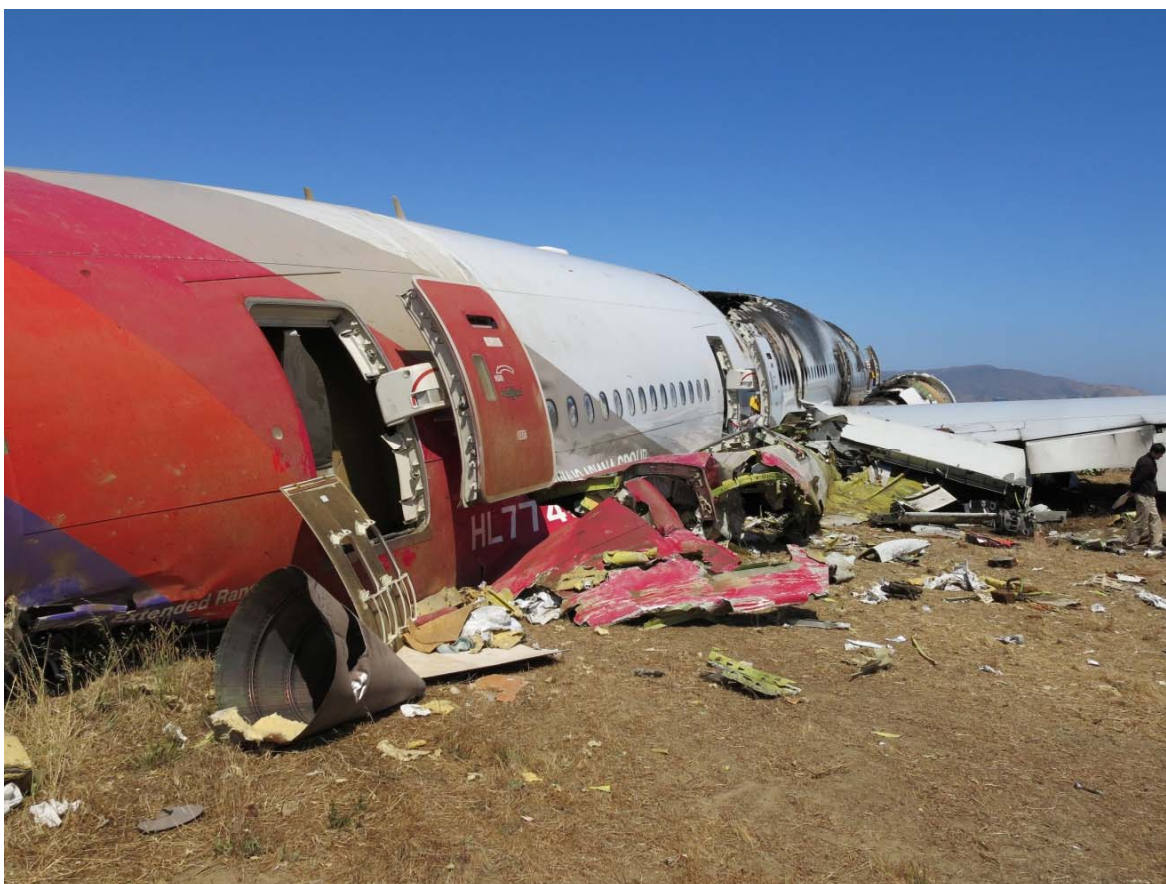
Photo 14. Door 4R.

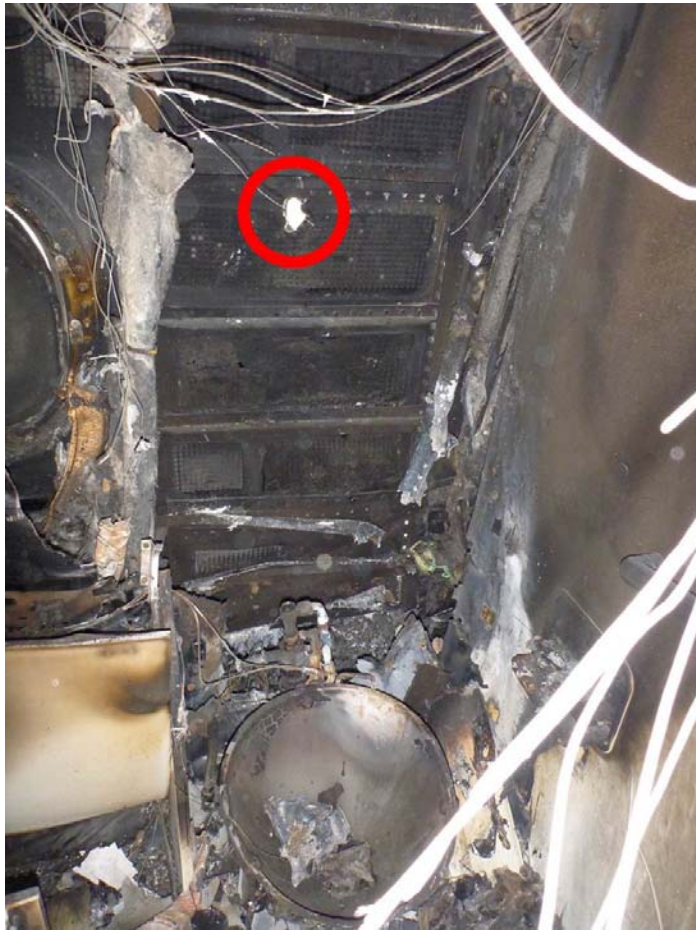
Photo 19. Interior view of Snozzle penetration hole in 2R lavatory.

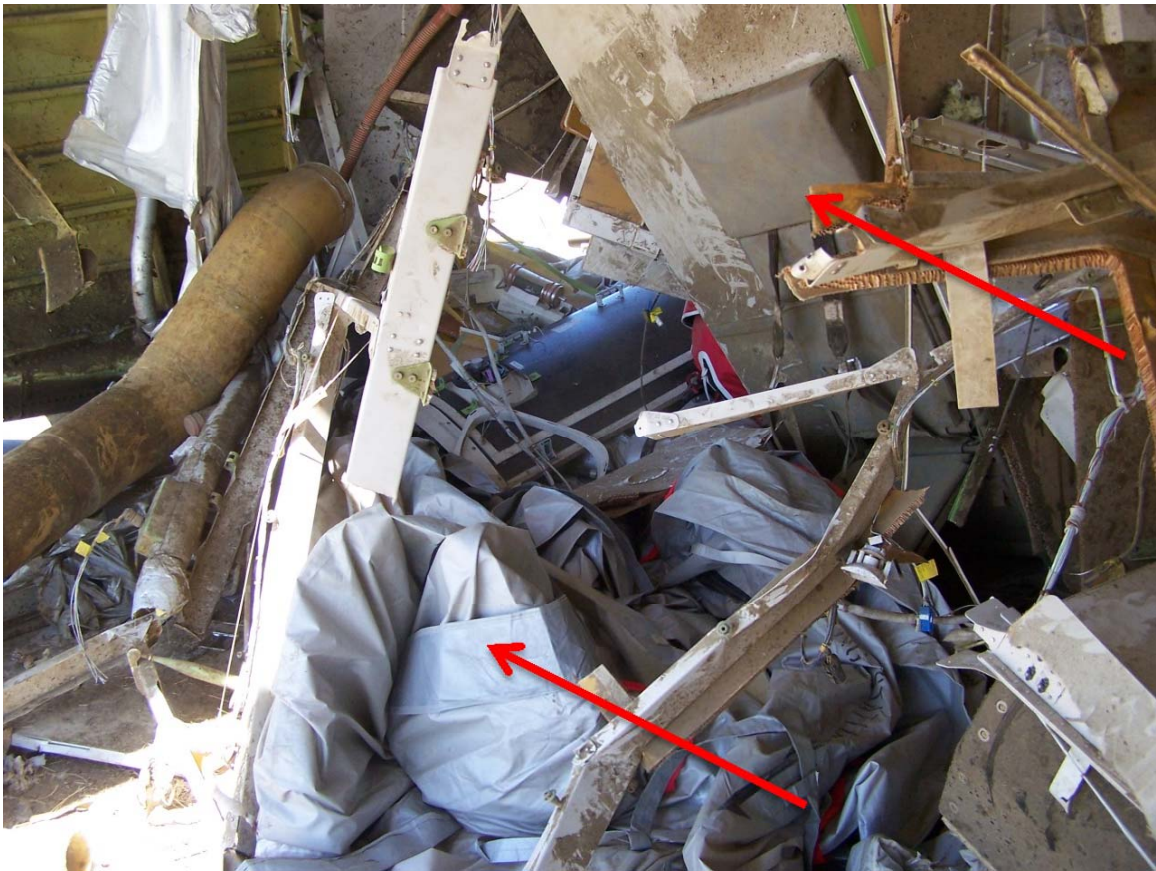
Photo 43. Forward-facing view of jumpseat M4A and 4L slide/raft.

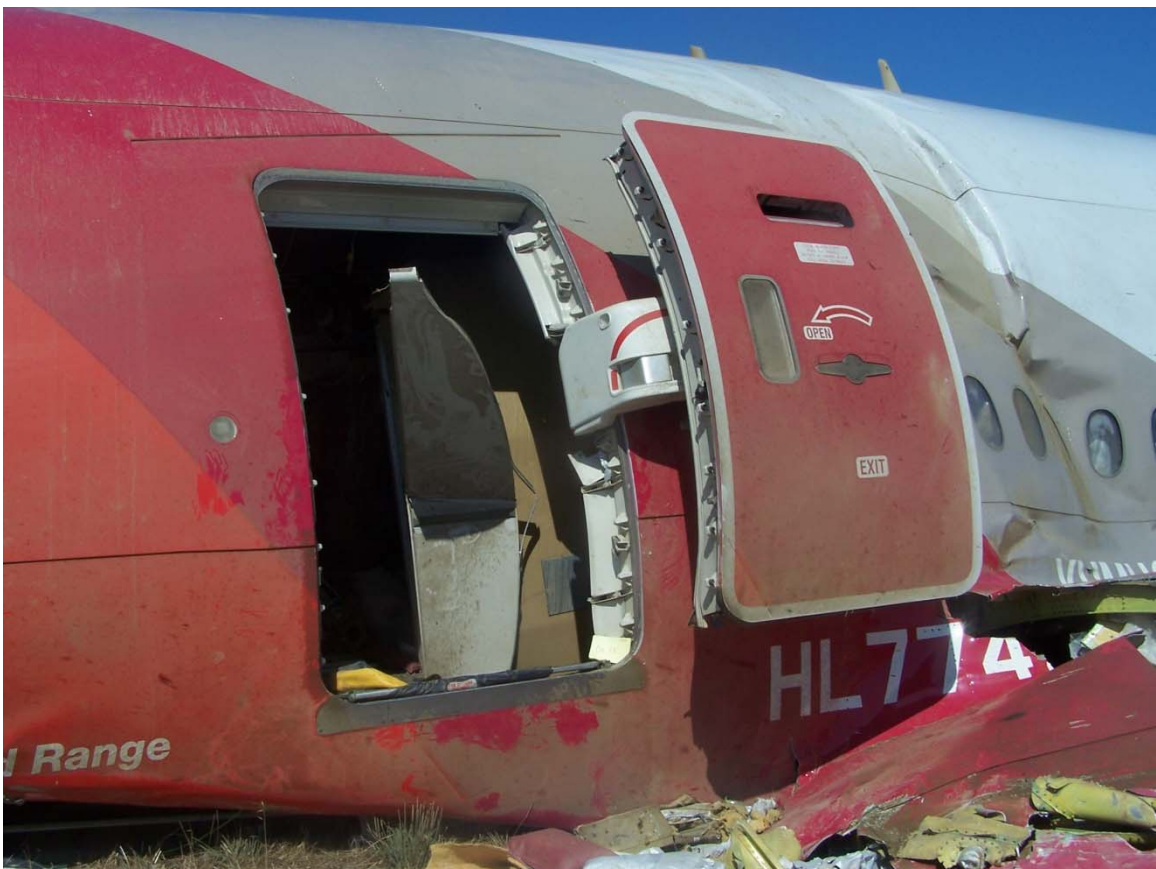
Photo 44. Door 4R.

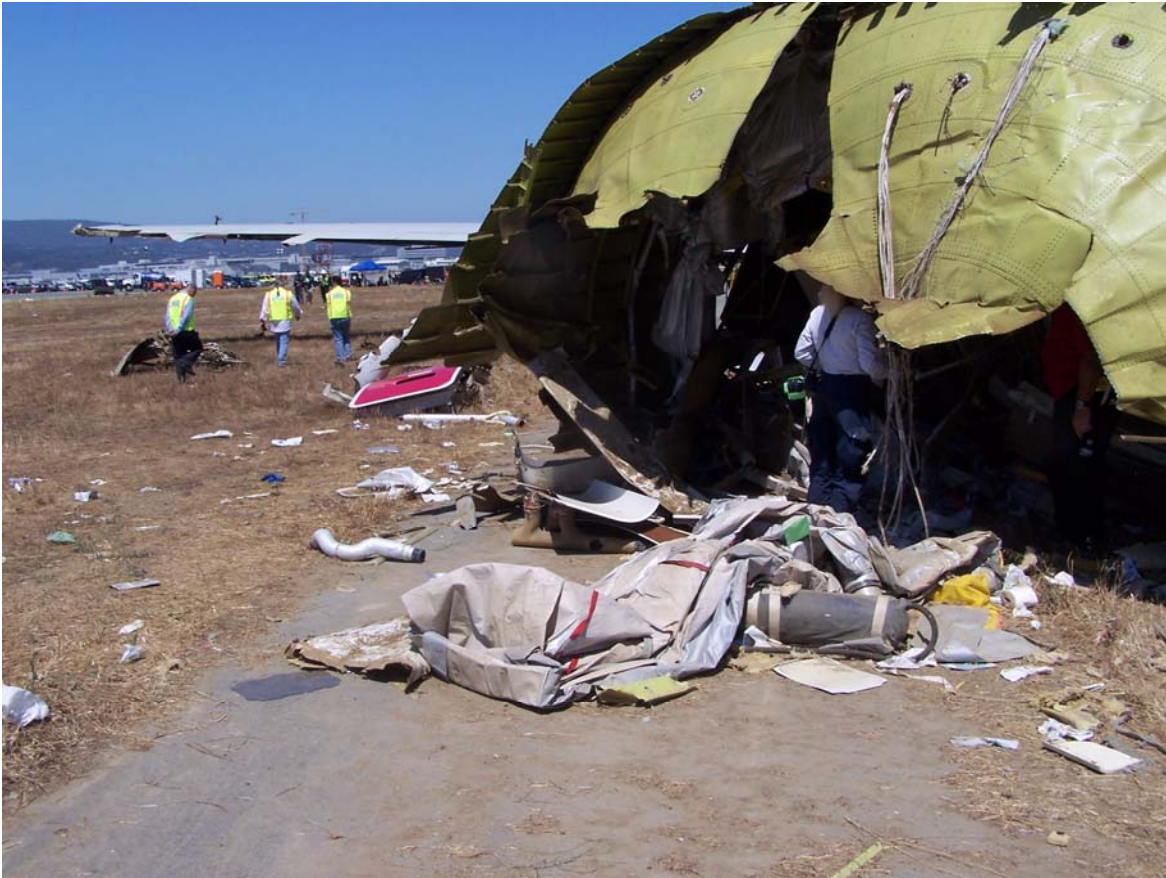
Photo 45. Door 4R slide/raft.

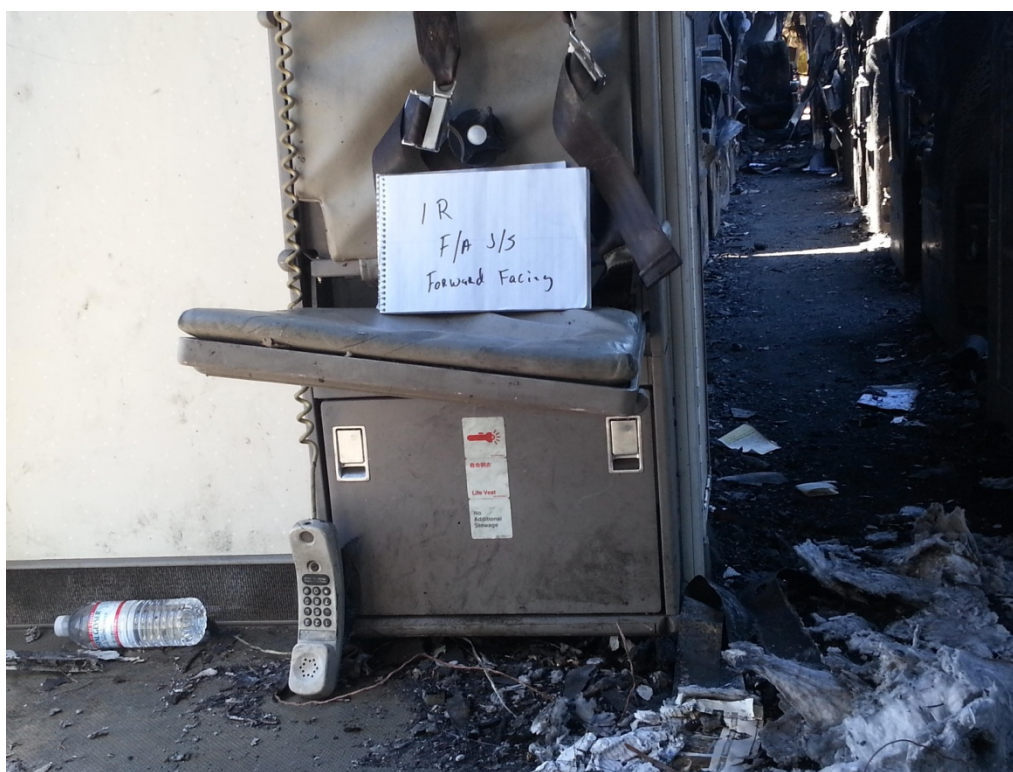
Photo 50. Deformation to seatpan of F/A jumpseat R1.

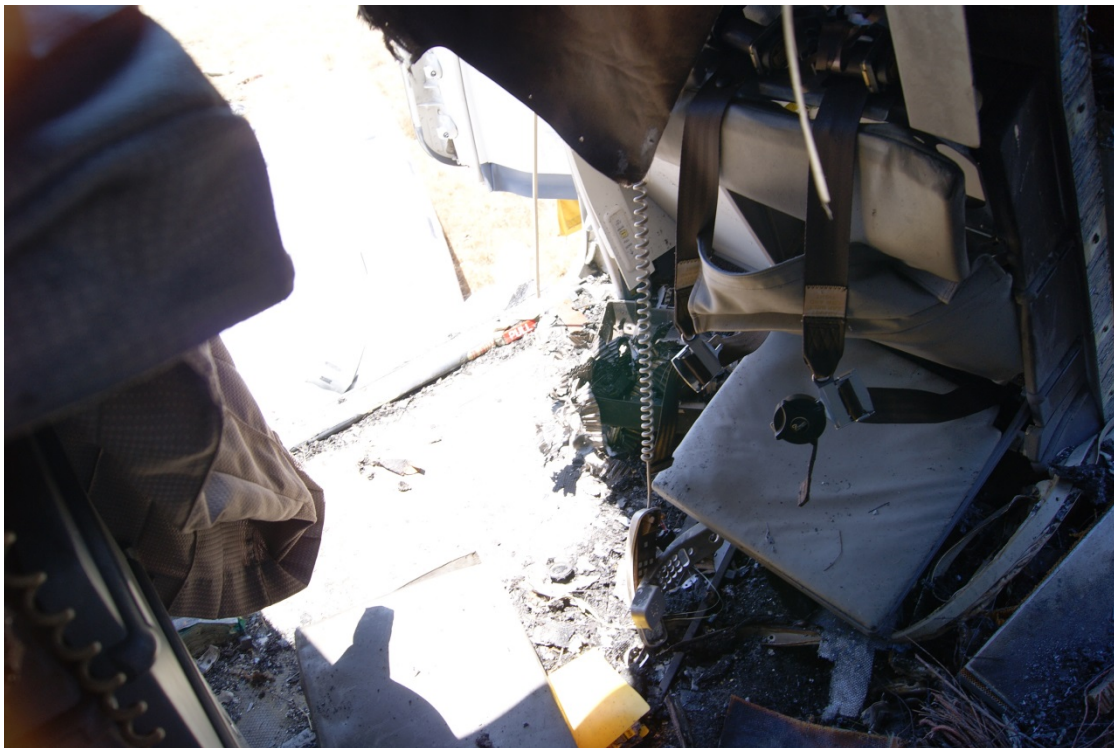
Photo 51. Aft-facing F/A jumpseat L2A.

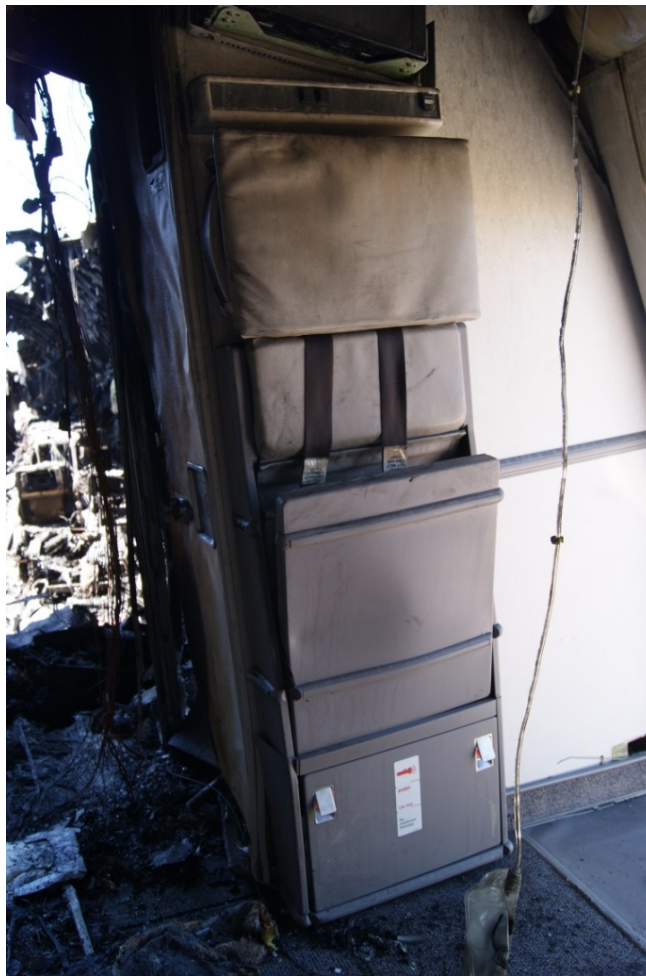
Photo 52. Aft-facing F/A jumpseat L2A.

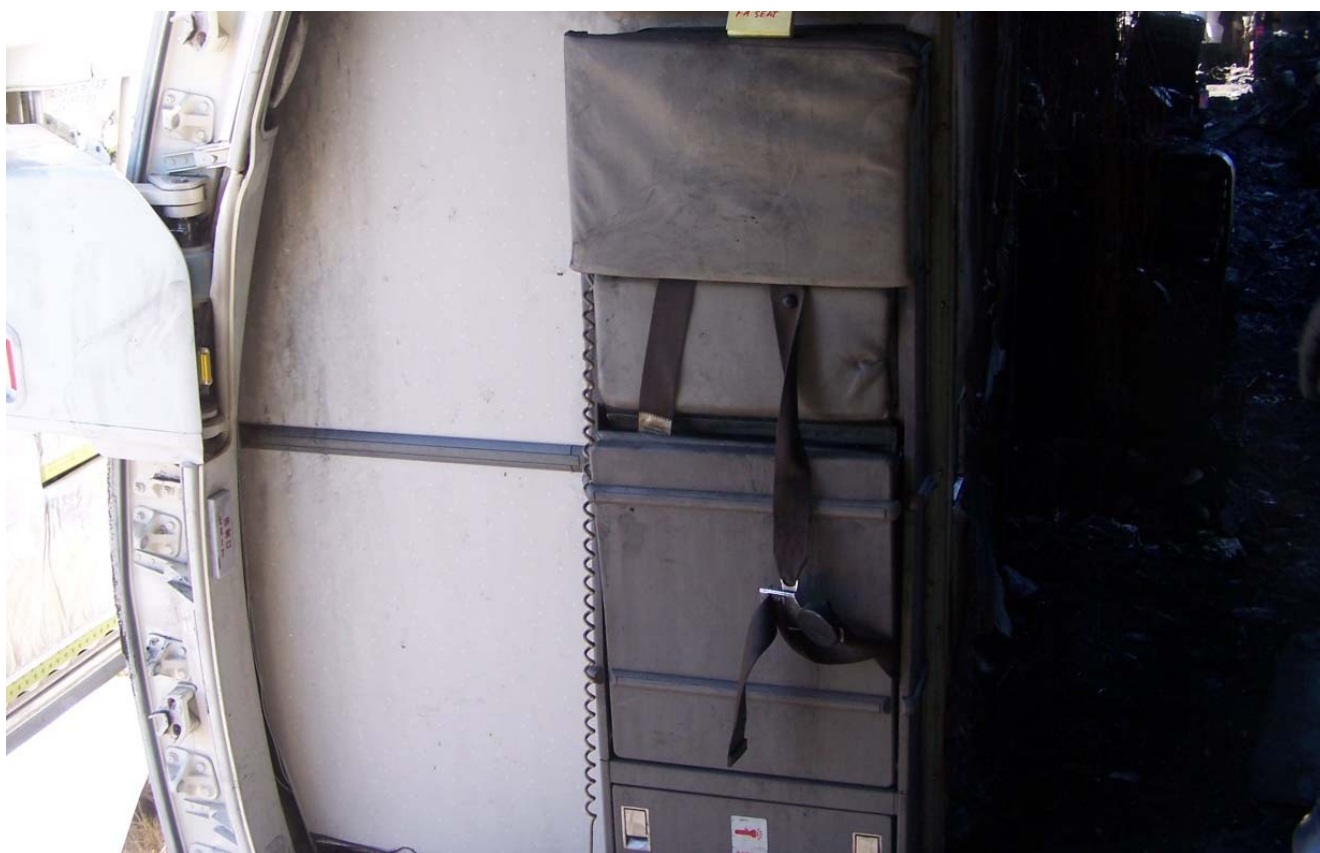
Photo 55. Forward-Facing jumpseat R2B.

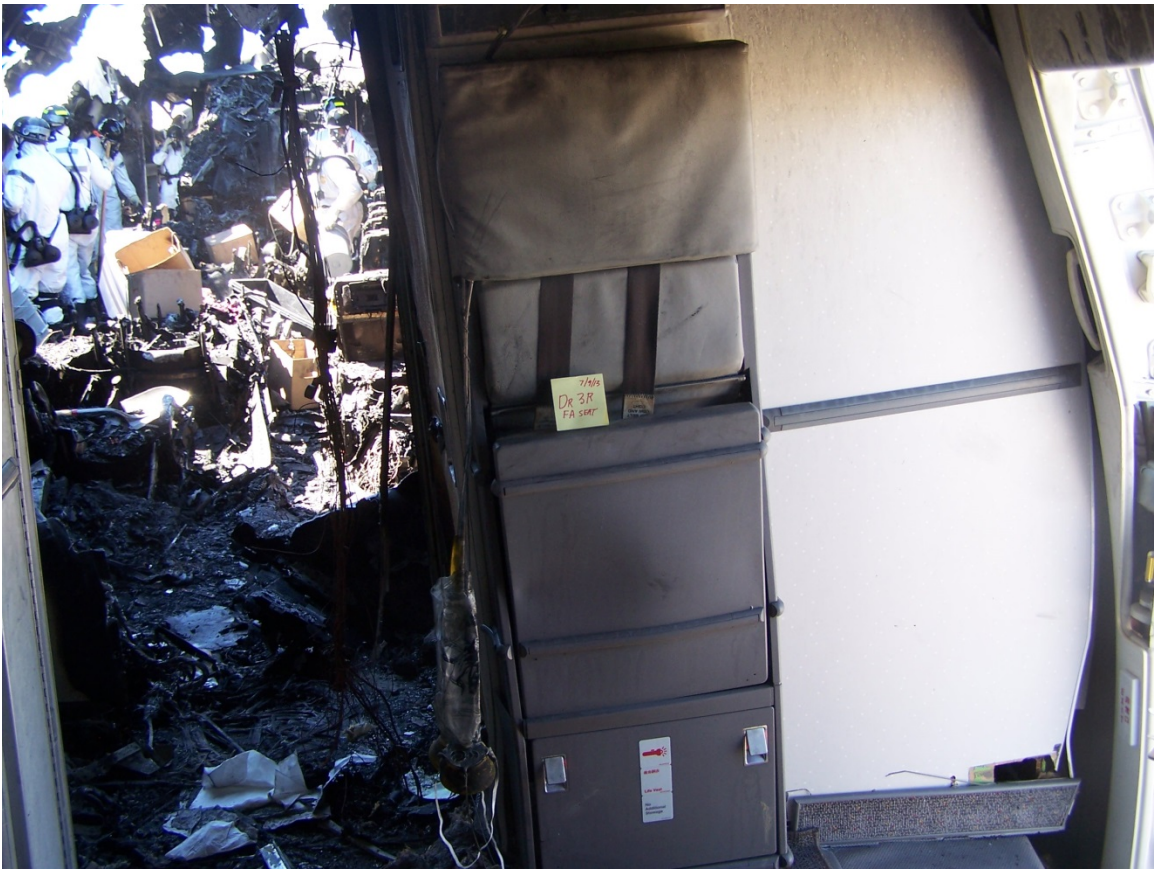
Photo 56. Aft-facing F/A jumpseat L3.

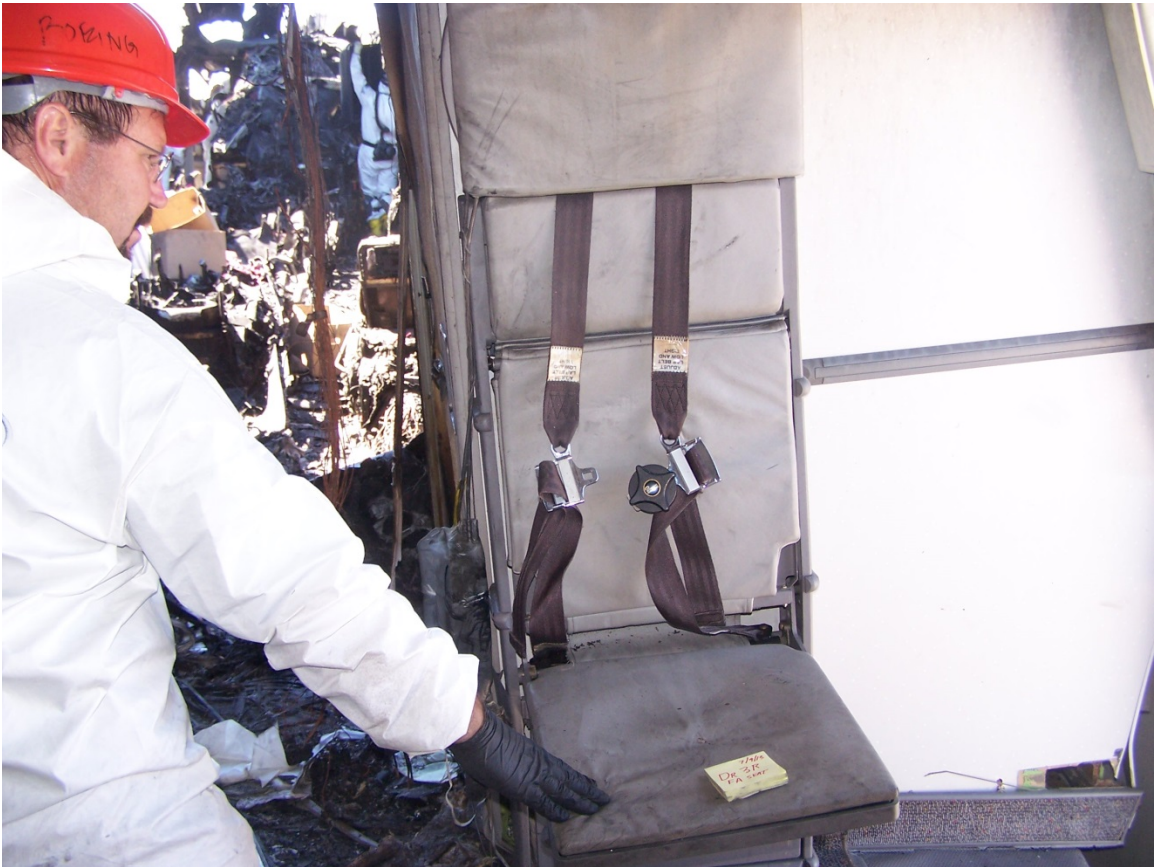
Photo 57. Aft-facing F/A jumpseat R3.
